Machinery Messages

Case History

Identification of a unique vibration problem

Alabama Power Corporation's Barry Steam Plant, located in Bucks, Alabama, operates a coal-fired, Westinghouse 270 MW cross compound steam turbine generator. This unit is composed of two separate machine trains - a high pressure (HP) train and

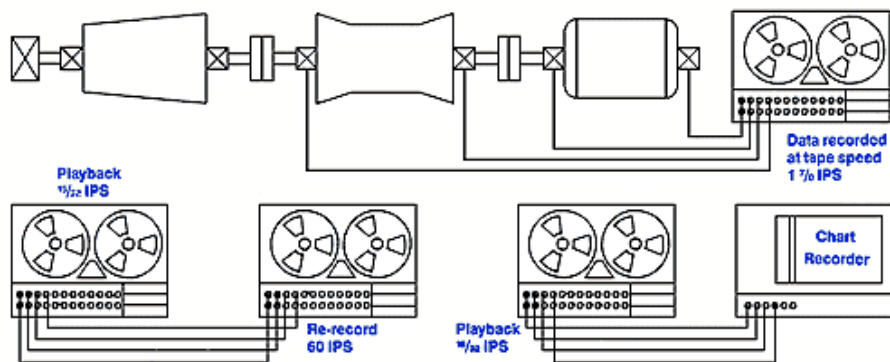
Process used to slow the event for analysis.

Figure 3 illustrates the process used to slow the event down enough to be analyzed. The data was played back at 15/32 in/sec, and re-recorded on a second tape recorder at 60 in/sec. This new tape was then played back at 15/32 in/sec (512 times slower than the original speed) to an analog chart recorder and a camera-equipped oscilloscope. One revolution of the shaft now took 8.533 seconds — long enough for an accurate documentation to indicate which signal was changing first.
